Long-Term Surveillance Plan for the Parkersburg, West Virginia, Disposal Site

September 1995

**Prepared for
U.S. Department of Energy
Albuquerque Operations Office
Grand Junction Projects Office**

**Prepared by
Rust Geotech
Grand Junction, Colorado
Work Performed Under DOE Contract No. DE-AC04-94AL96907**

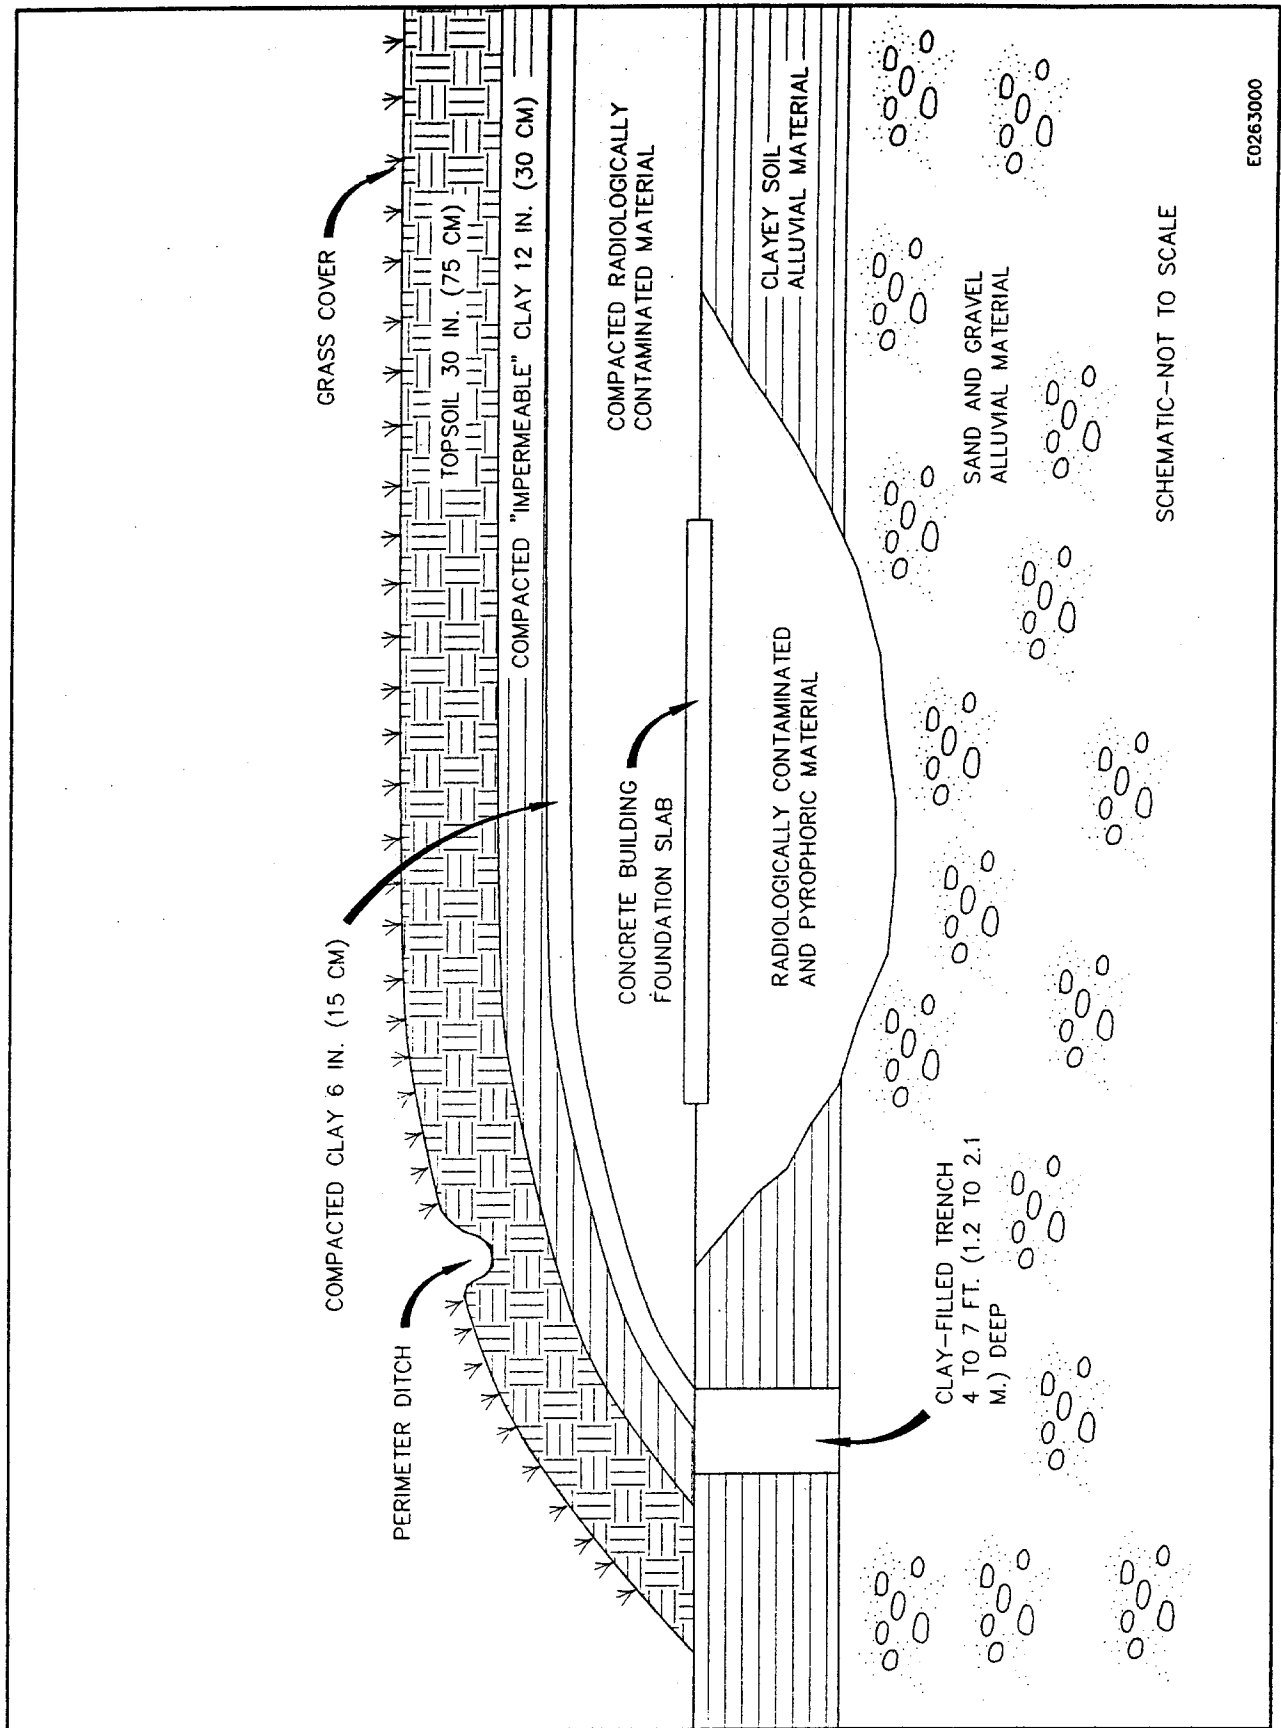
Figure 3-1 Conceptual Schematic Section of Stabilization Mound
 (Based on U.S. Nuclear Regulatory Commission, 1988, & AMAX Environmental Services, Inc., 1984)

Radiologically contaminated soil and debris placed on grade was compacted by D-8 bulldozers and tandem truck wheels. An inorganic clayey soil obtained from the field west of the site was spread over the contaminated material and compacted to a dense 6-in (15-cm) thick layer using a flat drum vibrator roller. A low permeability clay cap layer 12 in (30 cm) thick was constructed over the clayey soil layer to protect the waste material from leaching. The clay material, classified as CL and with a high percentage of inorganic clay, was selectively borrowed from the floodplain (a low terrace) just east of the Ohio River to the west of the site. Water was added as necessary to maintain optimum moisture content (about 20 percent) of the clayey material as it was spread by scrapers and compacted using a flat drum vibrator compactor. The clay material in compaction tests exceeded 90 percent density, and permeability of the layer was less than 1×10^{-7} cm/second (sec).

A 30-in. (75-cm) thick layer of topsoil was placed over the clay cap to protect it from weathering and erosion and to provide a soil base for growth of grass cover. The topsoil was obtained from borrow areas just west of the site and was compacted by a smooth drum vibrating compactor after being placed on the mound. The final 6 in. (15 cm) of topsoil was not compacted to allow for seeding of grass. Construction of the topsoil layer allowed surface drainage from all directions off the stabilization mound by limiting the final grade to between 1 and 5 percent over areas where the contaminated material had been placed. The final surface grade exceeded 5 percent at the southwest edge of the mound, which is outside the area where contaminated material was deposited. In late fall 1982, fertilizer, grass seed, and mulch were spread by hydromulch system over the final grade of the mound surface. The mixture

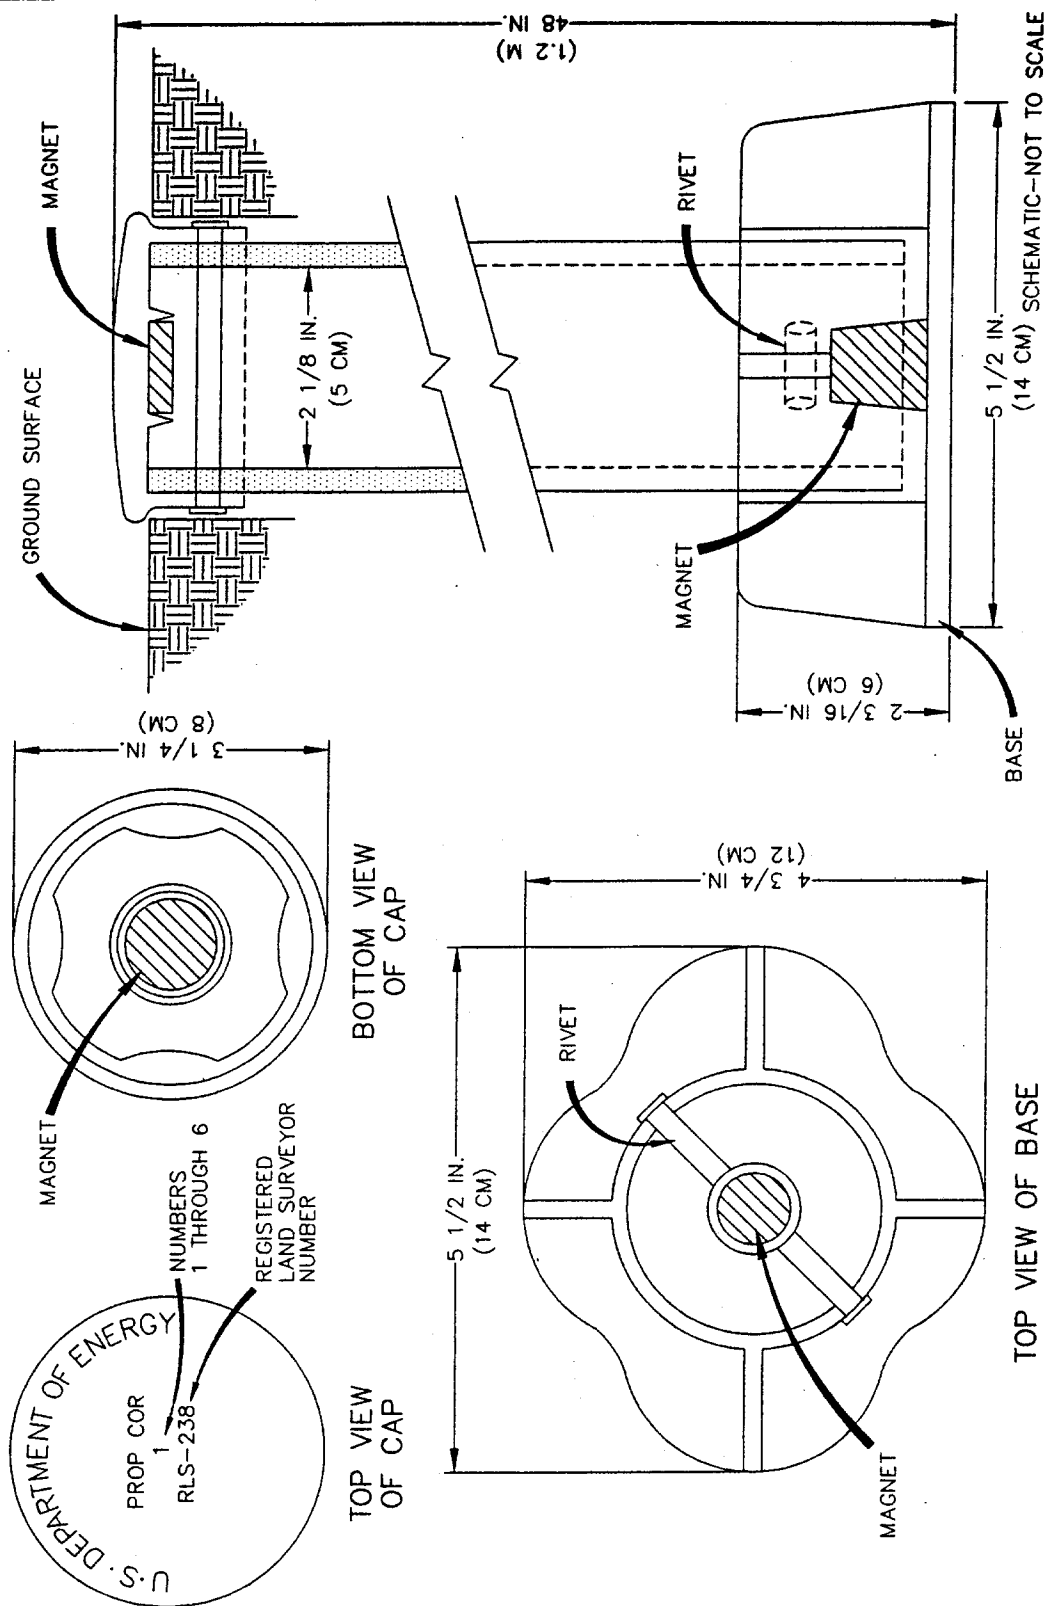
BERNTSEN FEDERAL ALUMINUM BOUNDARY MONUMENT,
MODEL A-1, STANDARD LOGO CAP

Figure 3-2 Boundary Monument at Parkersburg Site

Bernsten Federal aluminum survey monuments, Model A-1, were used for the six boundary monuments (Figure 3-2). Ceramic magnets are epoxied into the cap and base of each monument and are vertically oriented so that the monument can easily be found if it becomes buried. Each 4-ft (1.2-m) long monument is set with the cap within several inches above the ground surface. All the monuments are set exactly on the property line. Because of thick grass covering the stabilization mound and adjacent area, the boundary monuments may become difficult to locate with time. For this reason, a steel "T" bar fence post that stands 5 ft (1.5 m) above the ground surface was set beside each

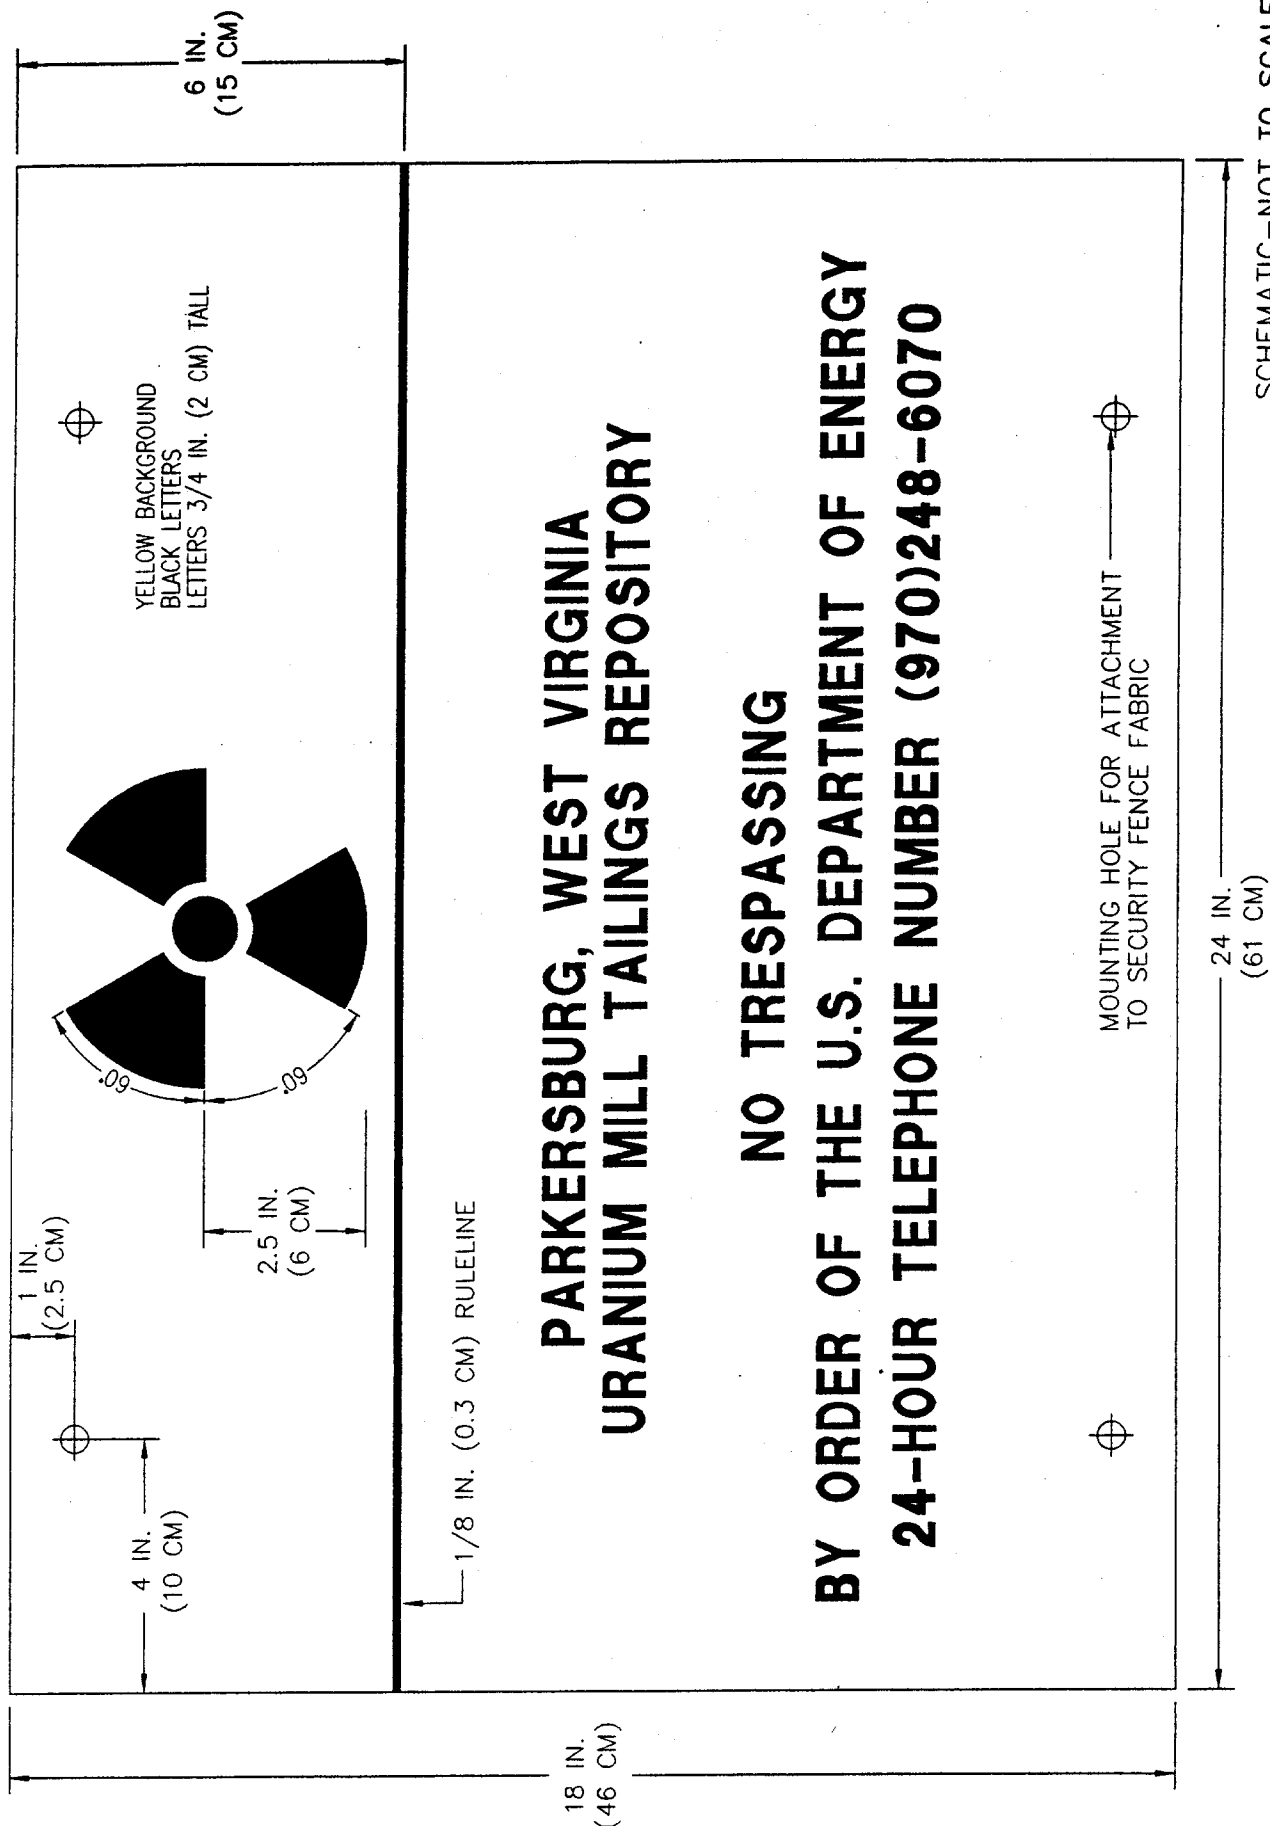
Figure 3-3 Warning Sign at Parkersburg Site

Fifteen aluminum warning or perimeter signs are bolted on the site security fence by aluminum straps and contain the following information: the name of the disposal site, the international symbol indicating presence of radioactive material, a notice that trespassing is forbidden on this Federally owned site, and the 24-hour telephone number for the DOE-GJPO. The signs are of the dimensions and specifications shown in Figure 3-3. The signs are situated no more than 200 ft (61 m) apart around the site security fence. The signs are numbered in counterclockwise order starting with the sign on the site entrance gate. Perimeter sign locations are shown on Plate 2. Whenever the DOE 24-hour telephone number changes, the new number will be shown on corrected signs.
